PRELIMINARY DAMAGE ASSESSMENT (PDA)  
**FOR FLOOD CONTROL PROJECT**

**PRELIMINARY DAMAGE ASSESSMENT**

**PA'AUAU FLOOD CONTROL PROJECT  
ISLAND OF HAWAII, HAWAII**

**19 March 2004**

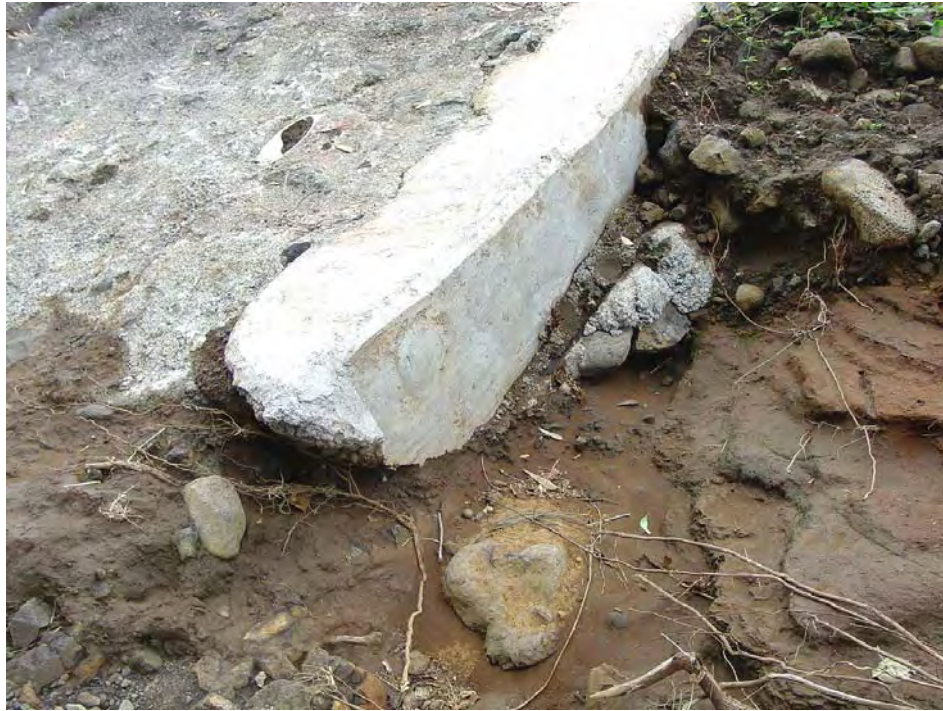
- a. Sta. 35+00, Toe at top end of project, tie back needs repair

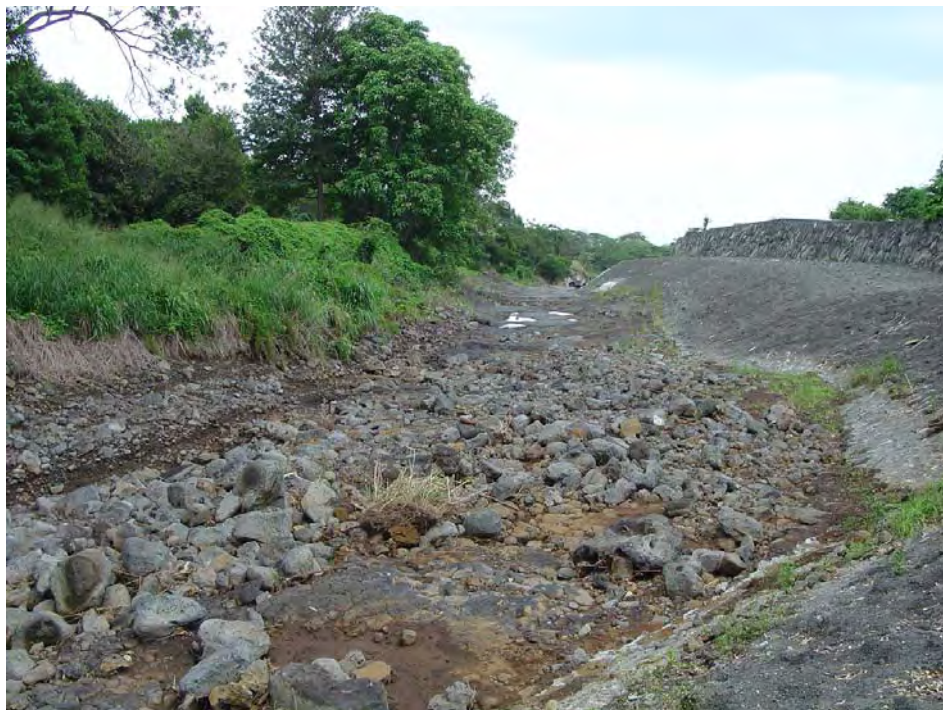
- b. Sta. 34+25 (approx) to 35+00, cleanout boulders and sediment in channel

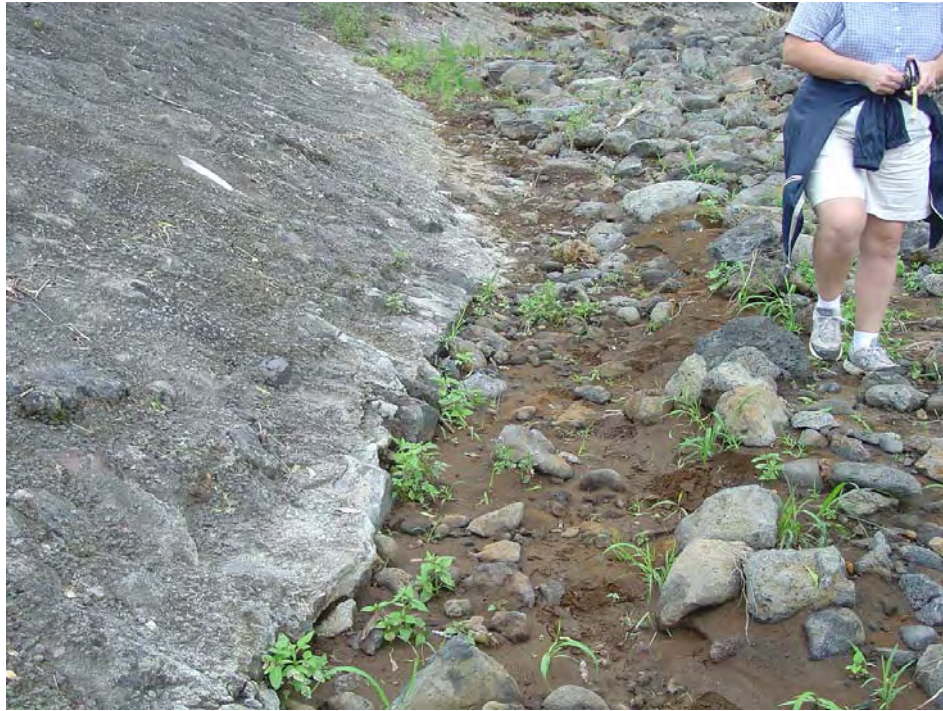
c. Sta. 33+80 (approx), 21 LF toe repair below Floodwall A

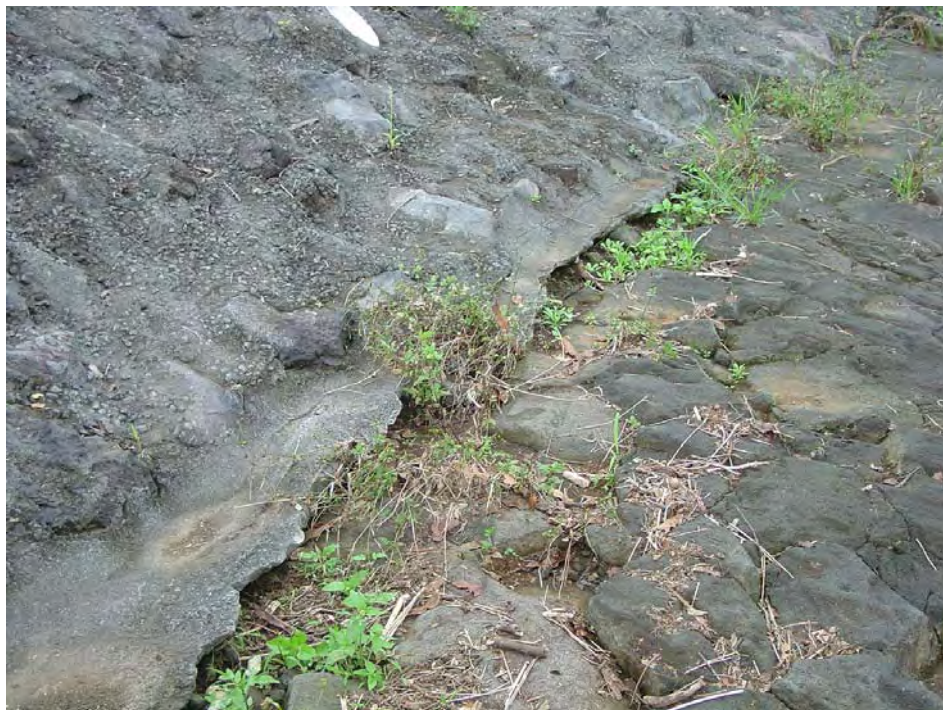
d. Sta. 32+00 (approx), 14 LF toe repair below Floodwall A

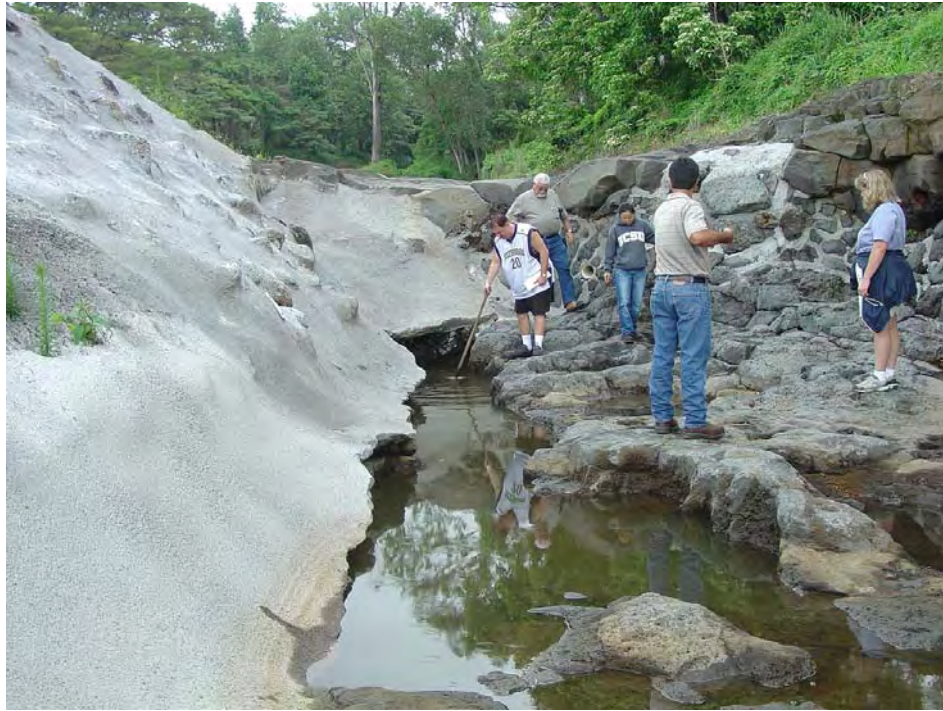
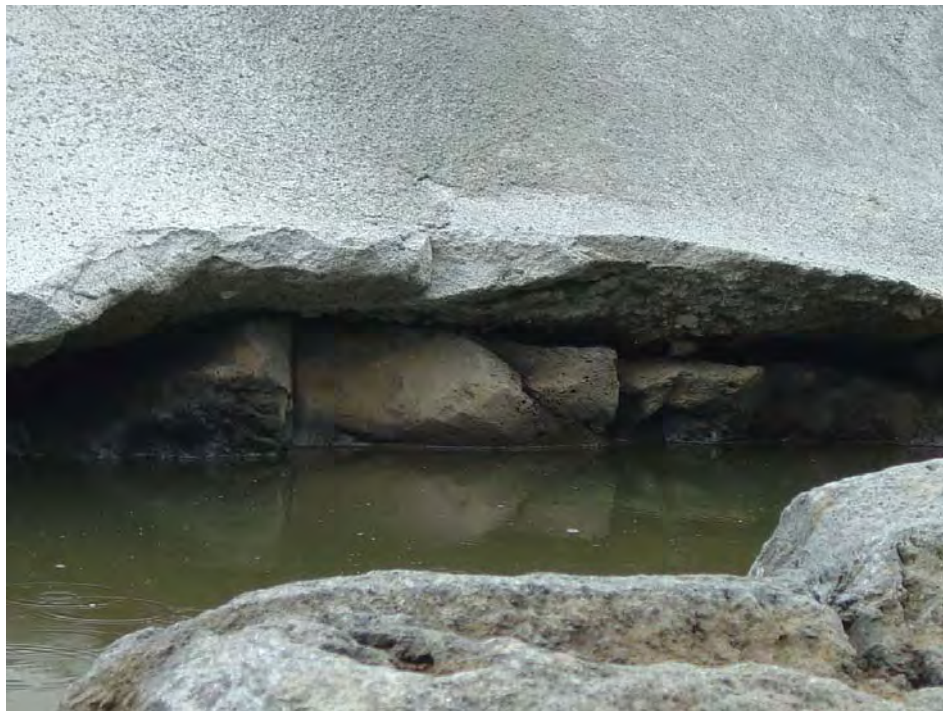
- e. Sta. 31+00, 36 LF toe repair (top & bottom photos), depth of hole 32 inches (top photo)

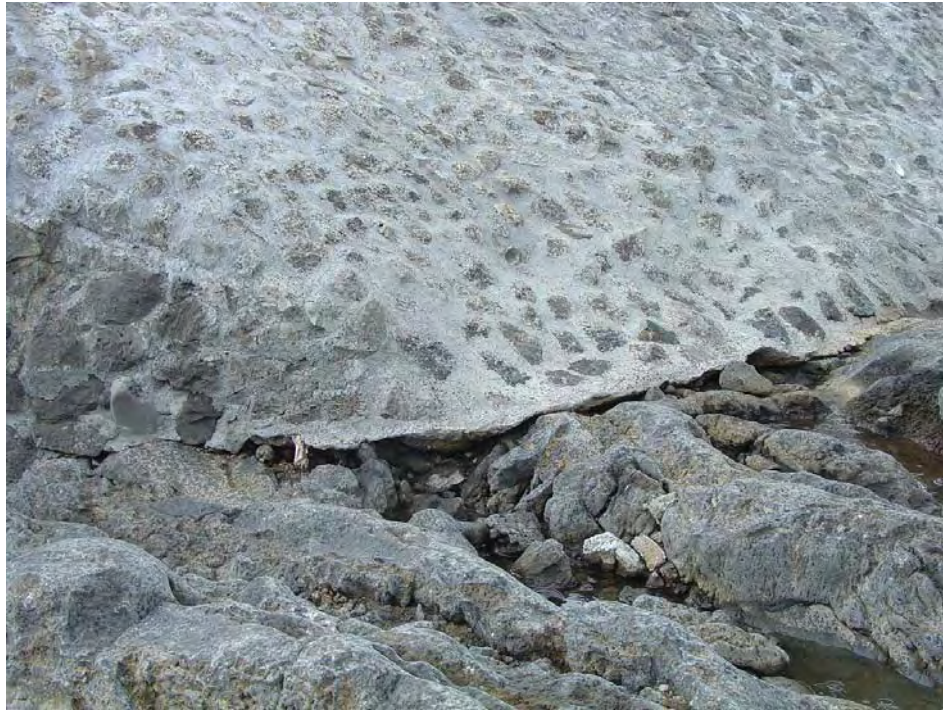
f. Sta. 29+50 (approx), 27 LF toe repair

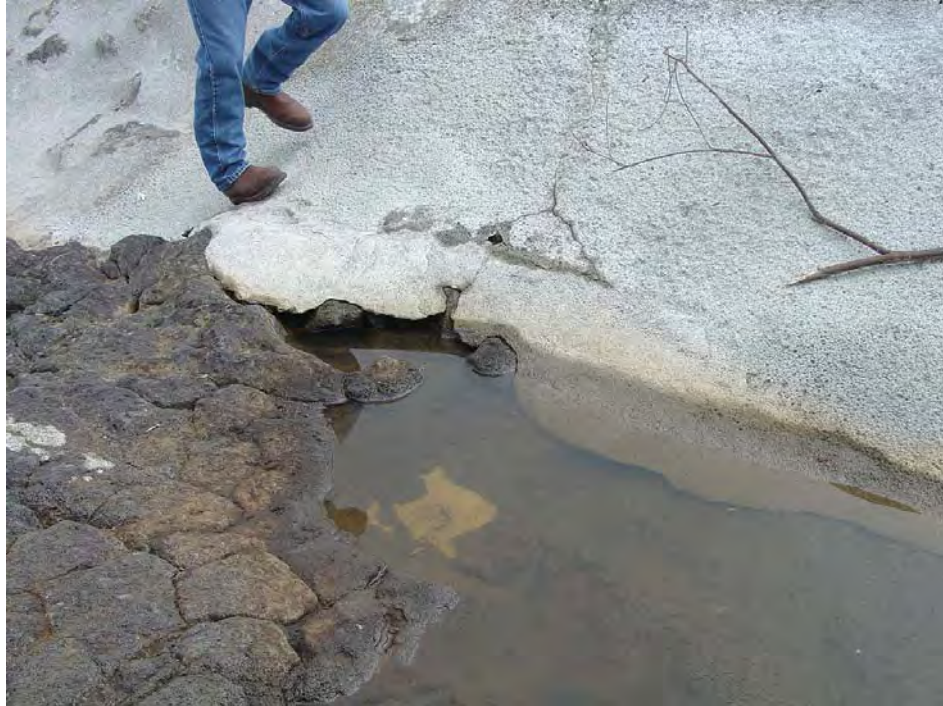
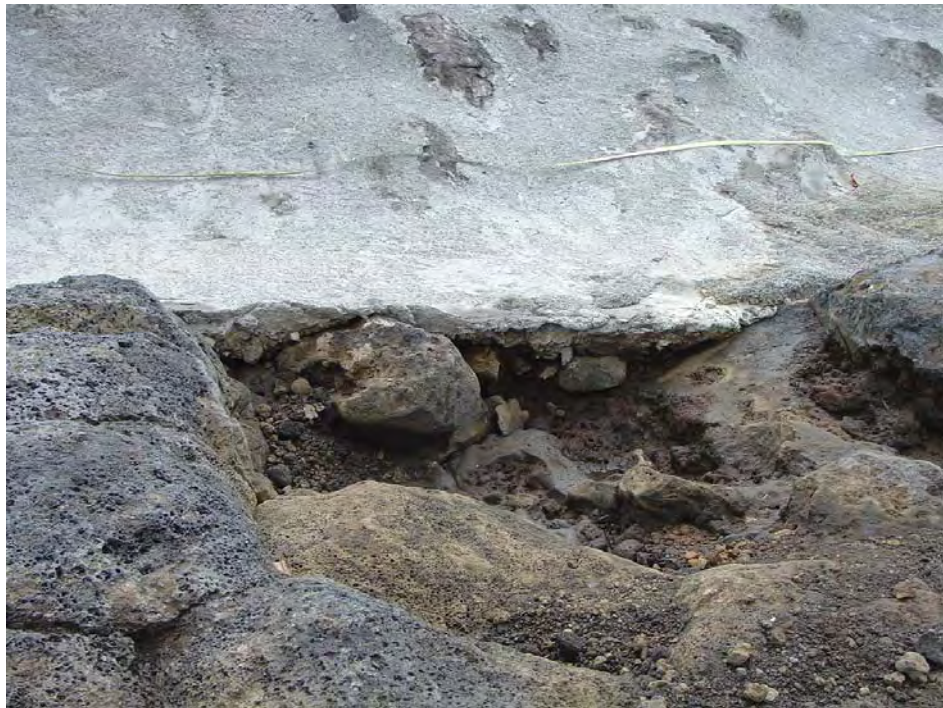
g. Sta. 27+50 (approx), 14 LF boulder slope concrete lining toe repair between Floodwalls A & B

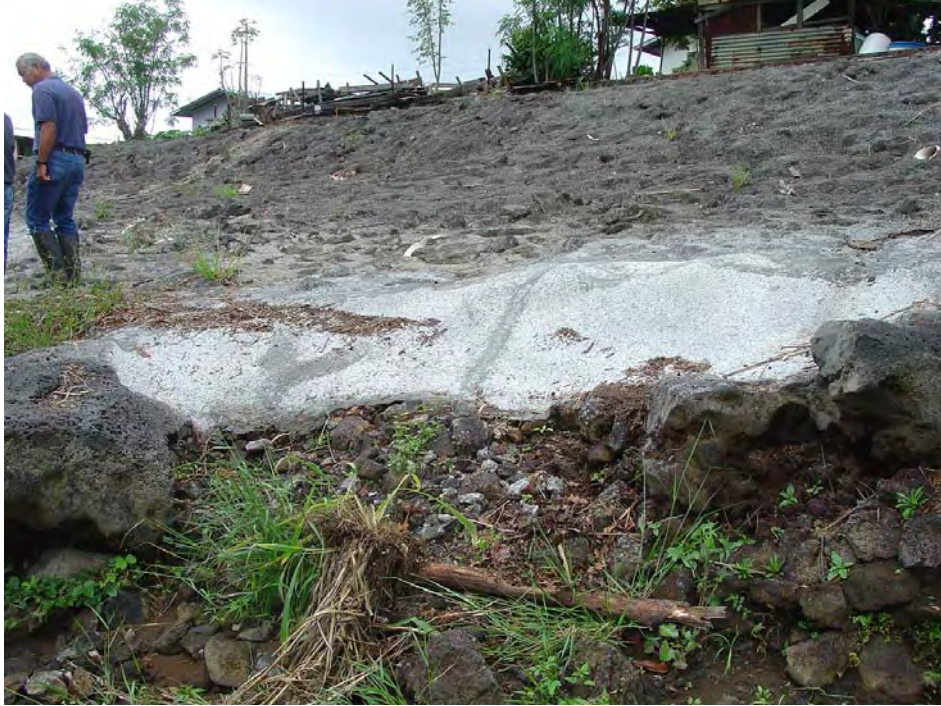
- h. Sta. 26+50 to 27+00 (approx), crack in concrete needs repair (top photo) and 42 LF toe flaking needs repair (top & bottom photos)

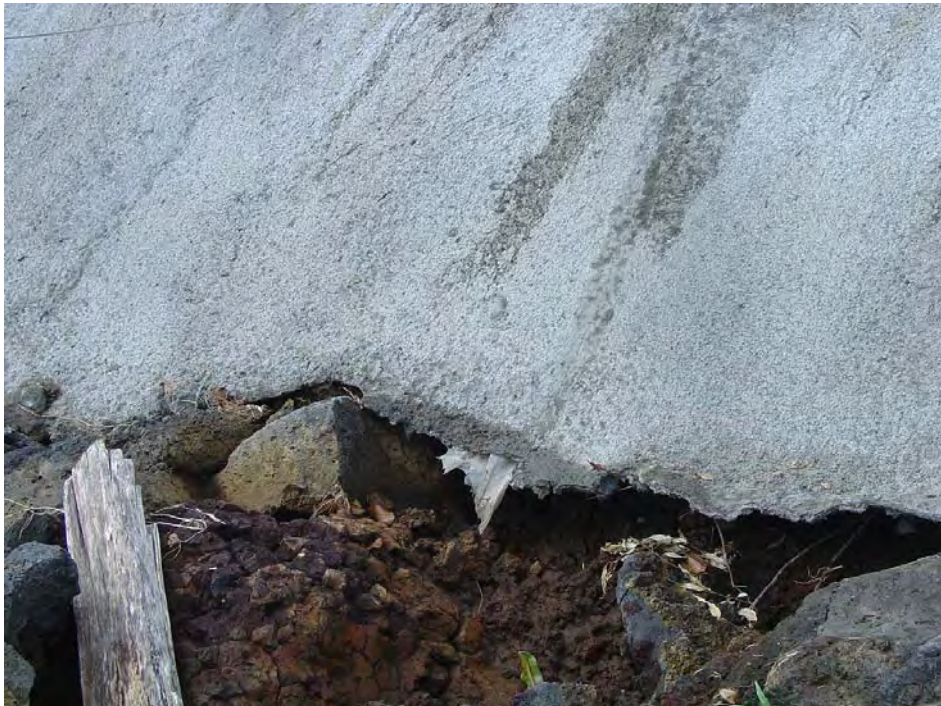
- i. Sta. 24+00 (approx), 13 LF toe repair

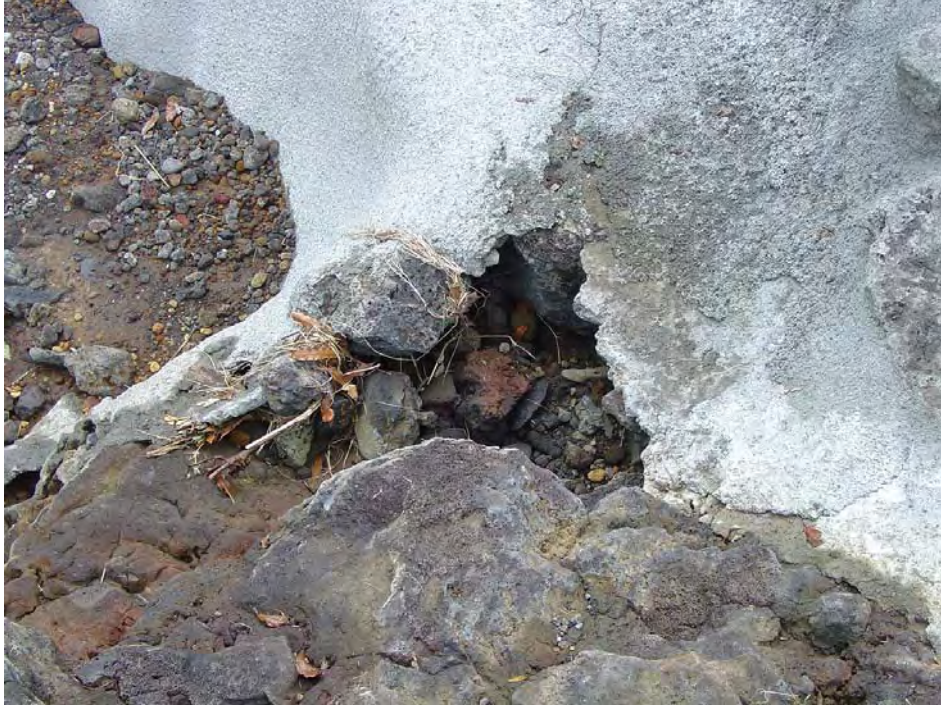
- j. Sta. 21+80 (approx), 46 LF CBSL toe failure, between Floodwalls B & C

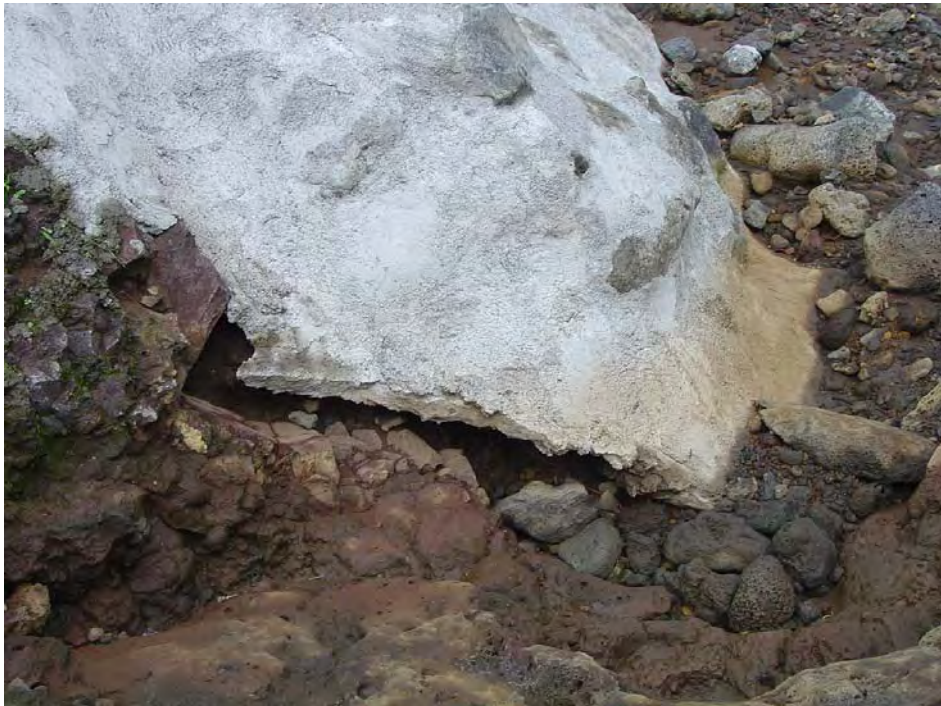
- k. Sta. 21+00 (approx), toe repair, below Floodwall C

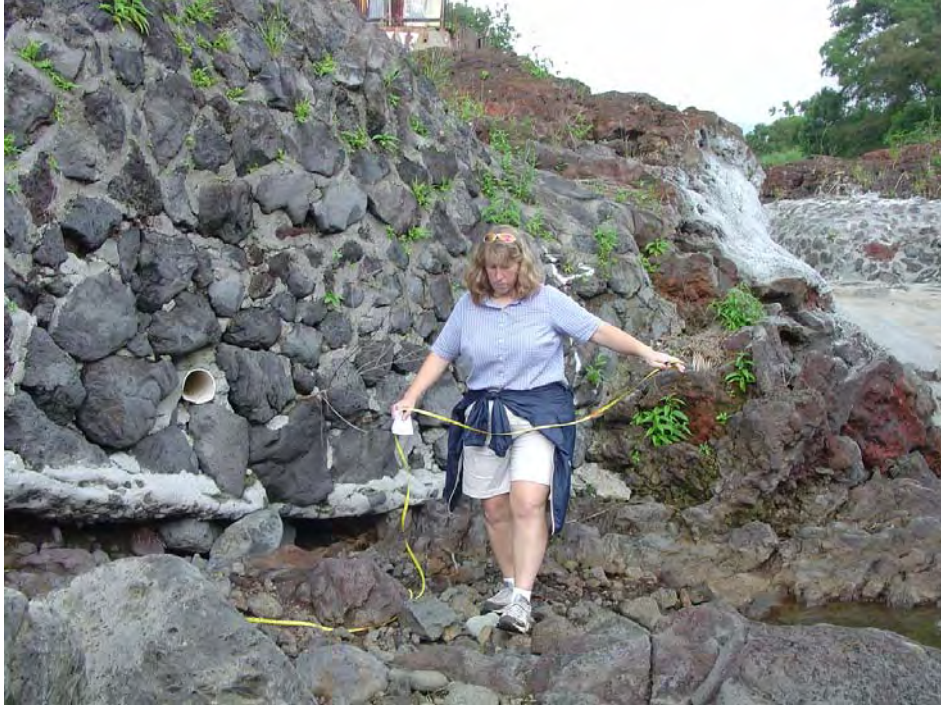
- l. Sta. 20+40 (approx), 4 LF toe repair

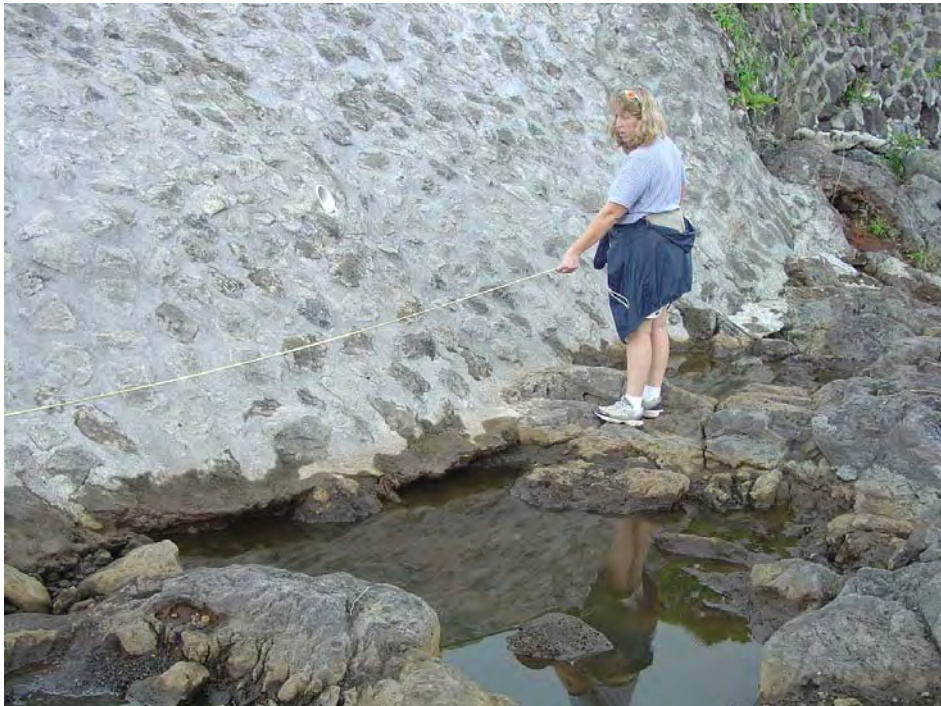
- m. Sta. 18+30 (approx), 35 LF toe repair, between Floodwall C & D

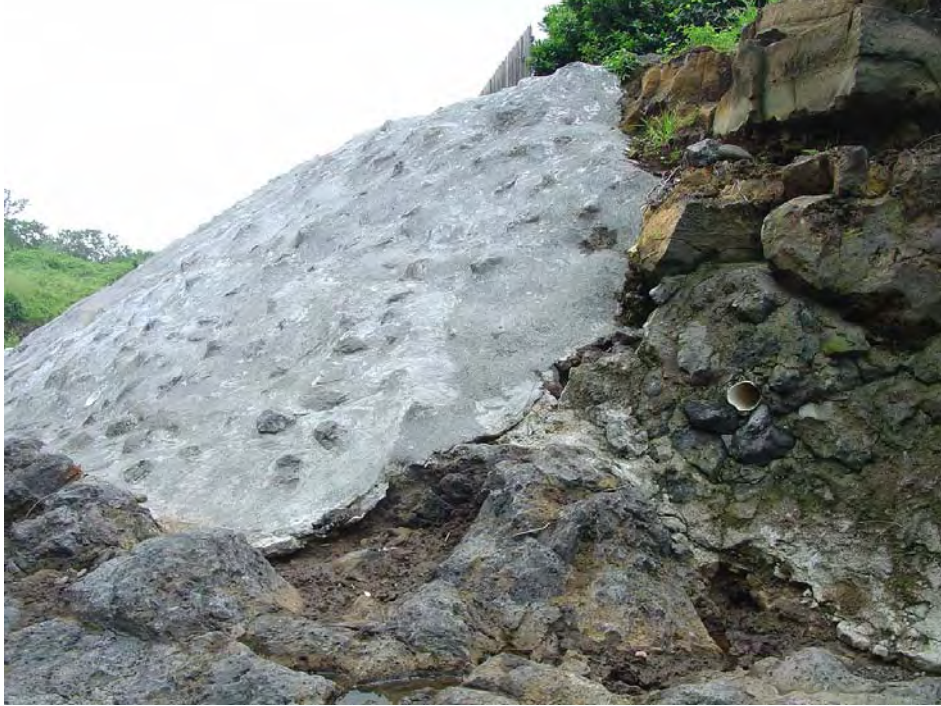
- n. Sta. 18+00 (approx), 25 LF toe of boulder concrete slope (BCS)

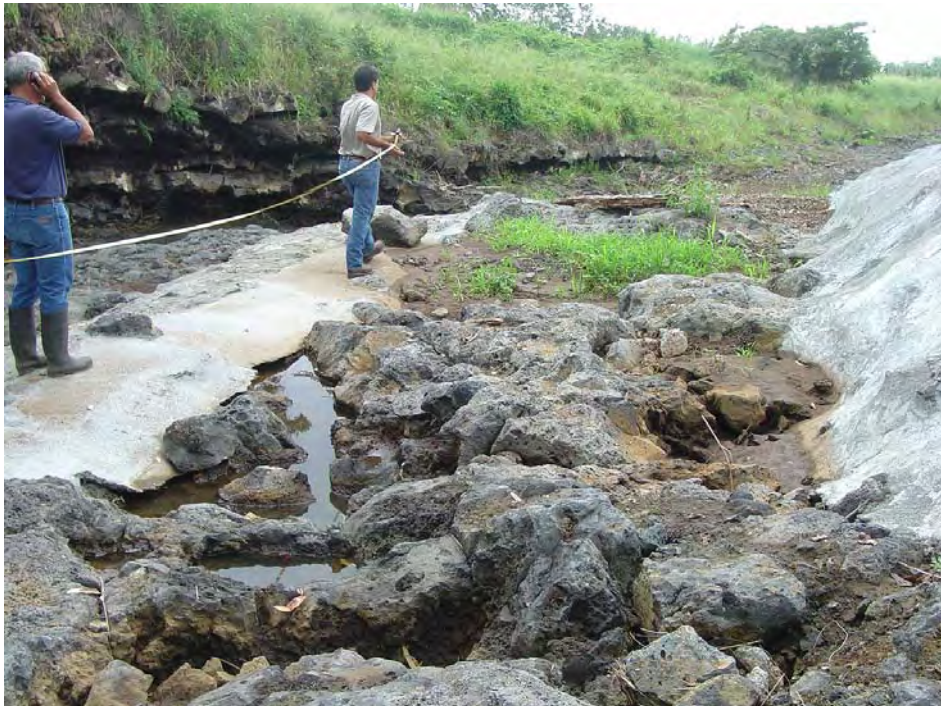
- o. Sta. 17+00 (approx), toe repair at the beginning of BCS, below Floodwall D

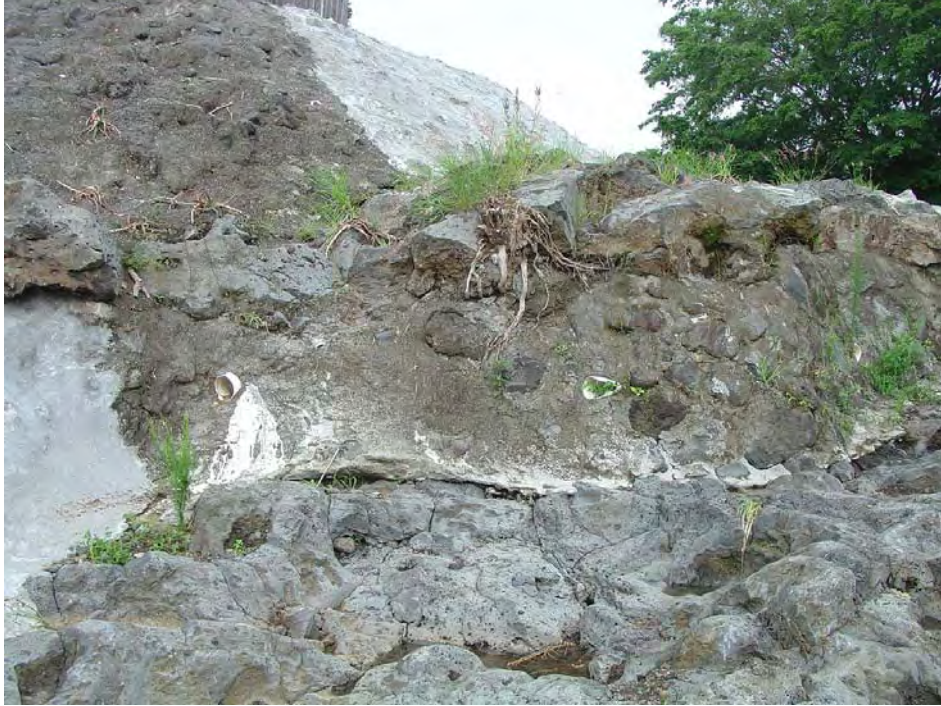
- p. Sta. 16+27 (approx), 40 LF X 12 LF wide need to tie hole into structures

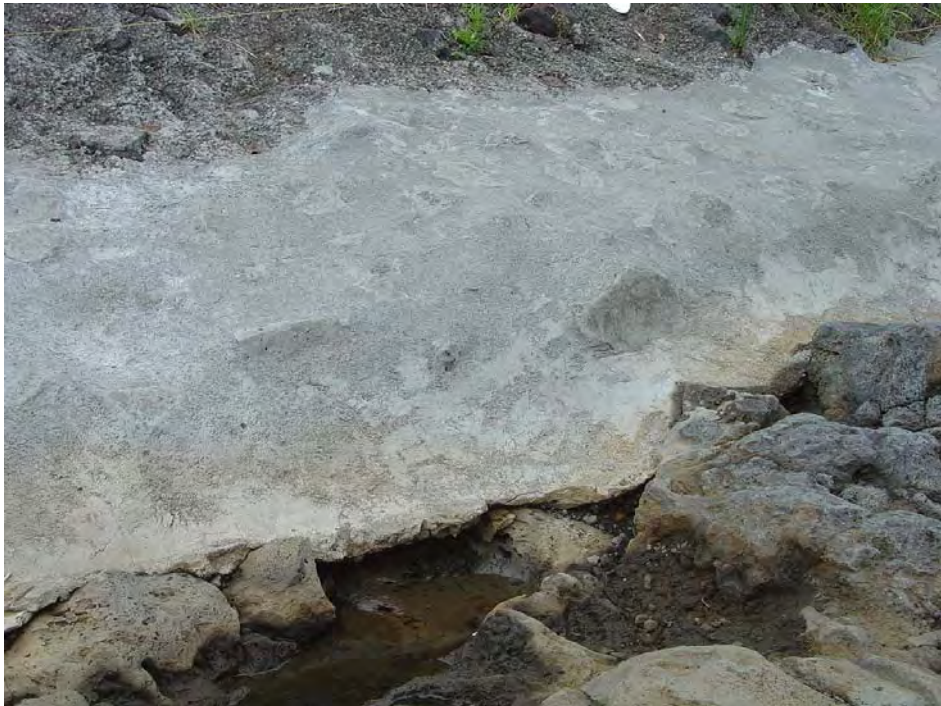
- q. Sta. 16+00 (approx), 6 LF toe repair, downstream end of Floodwall D

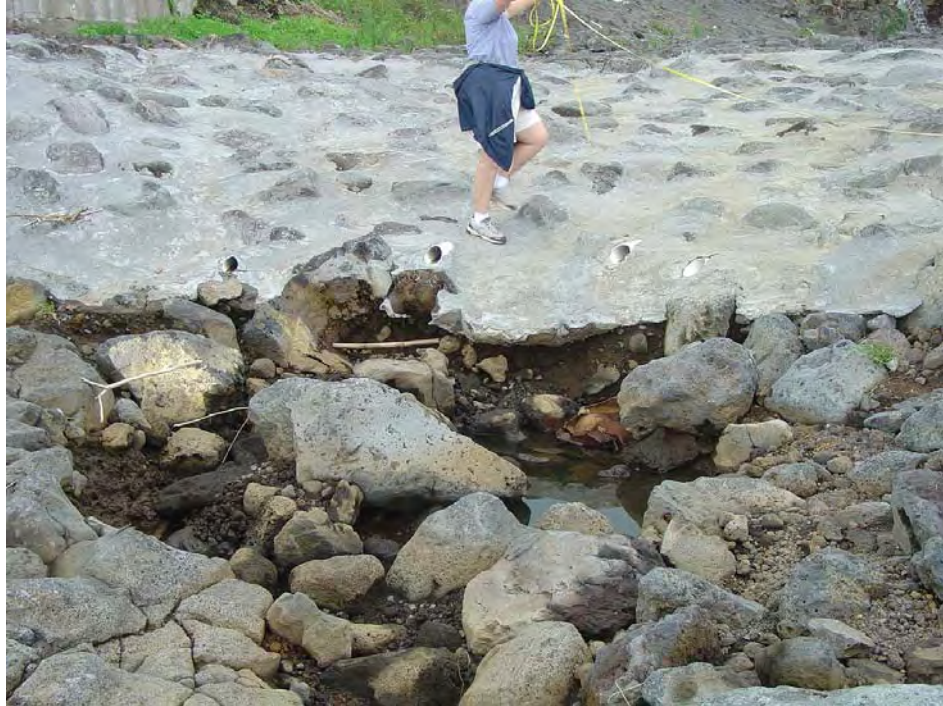
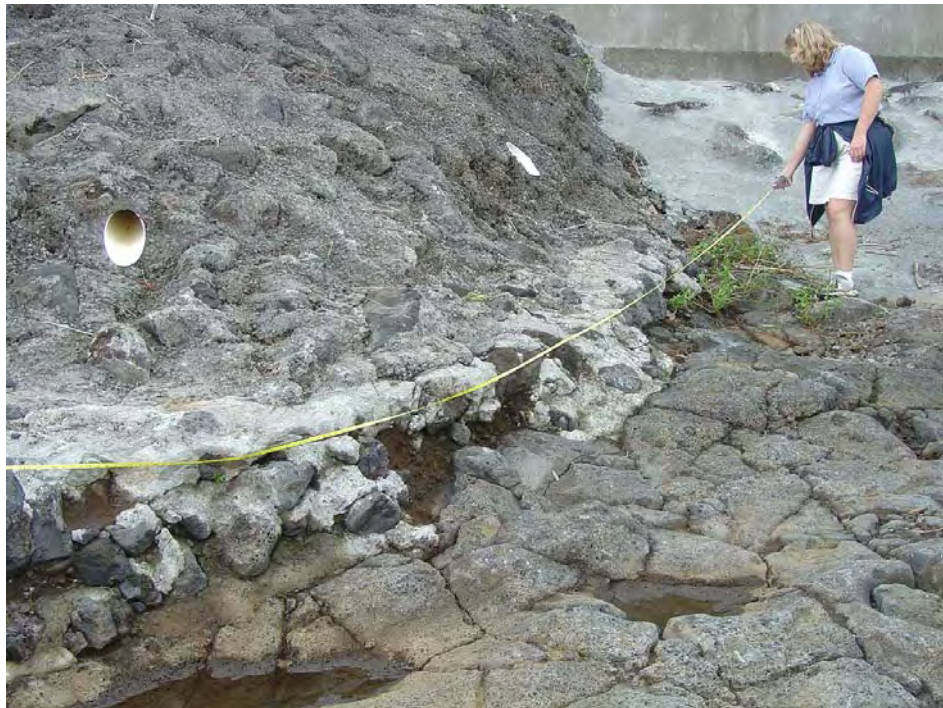
r. Sta. 15+70 (approx), 15 LF toe repair

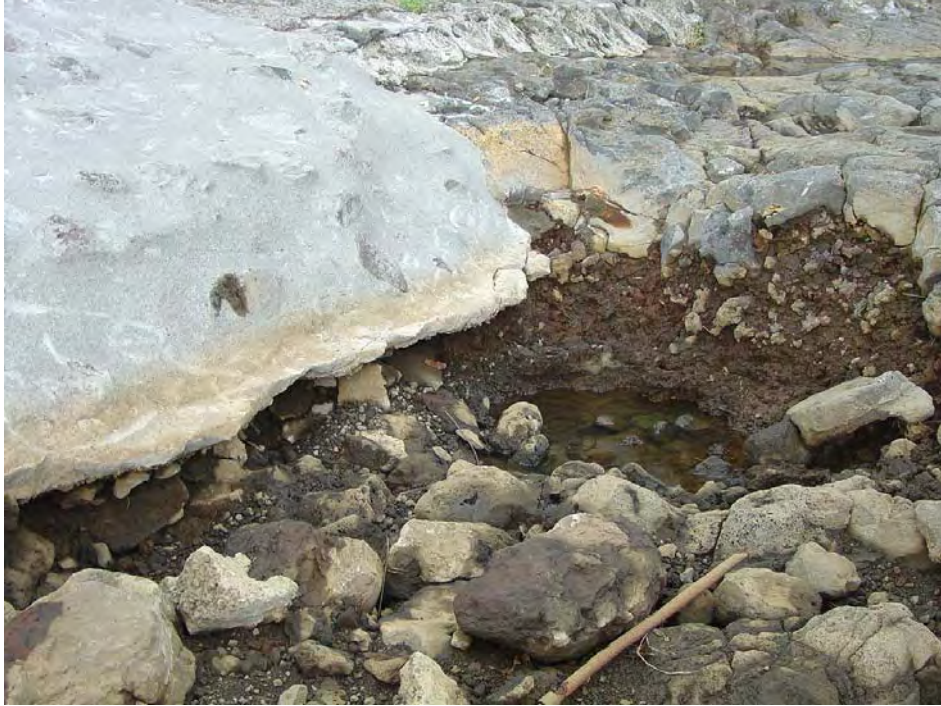
- s. Sta. 14+25 (approx), patch hole 34 LF across (top photo), 25 LF toe repair (top and bottom photo), upper end of Floodwall E

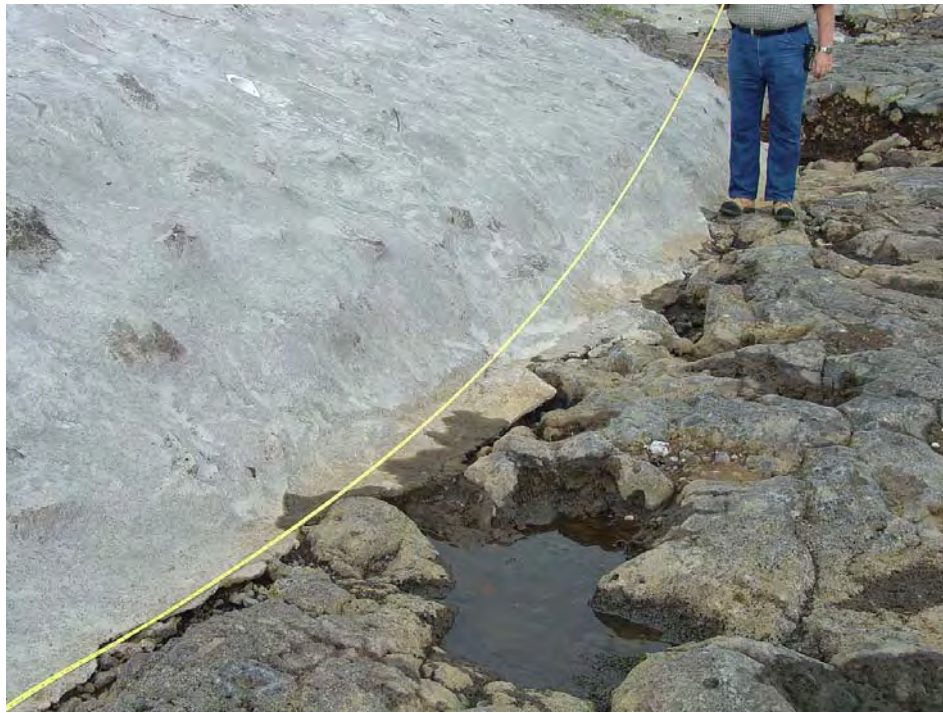
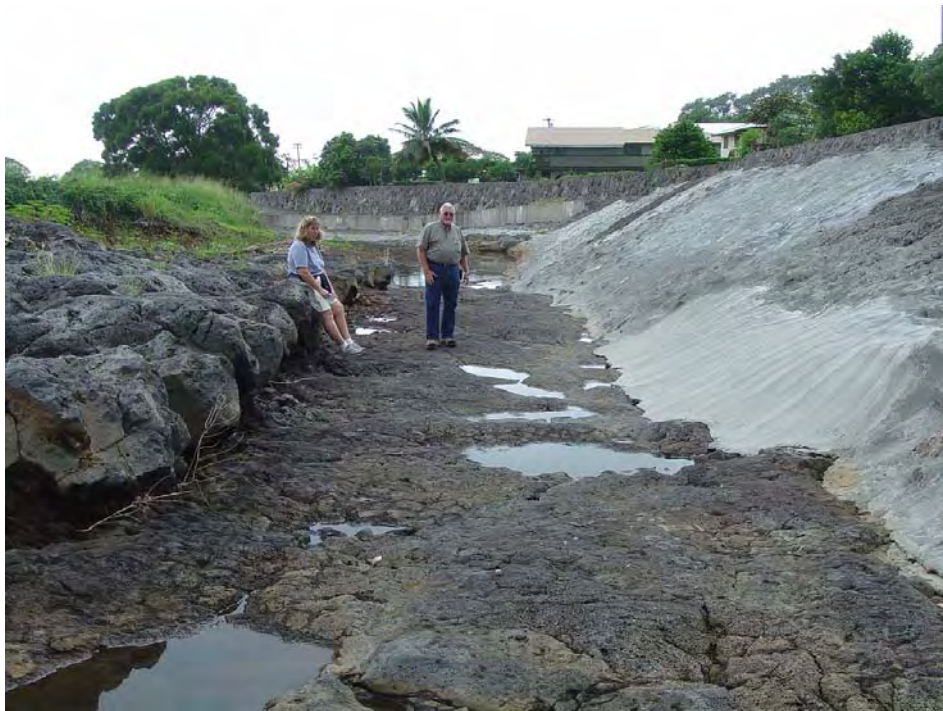
- u. Sta. 13+20 (approx), 65 LF toe repair, toe needs to be keyed in

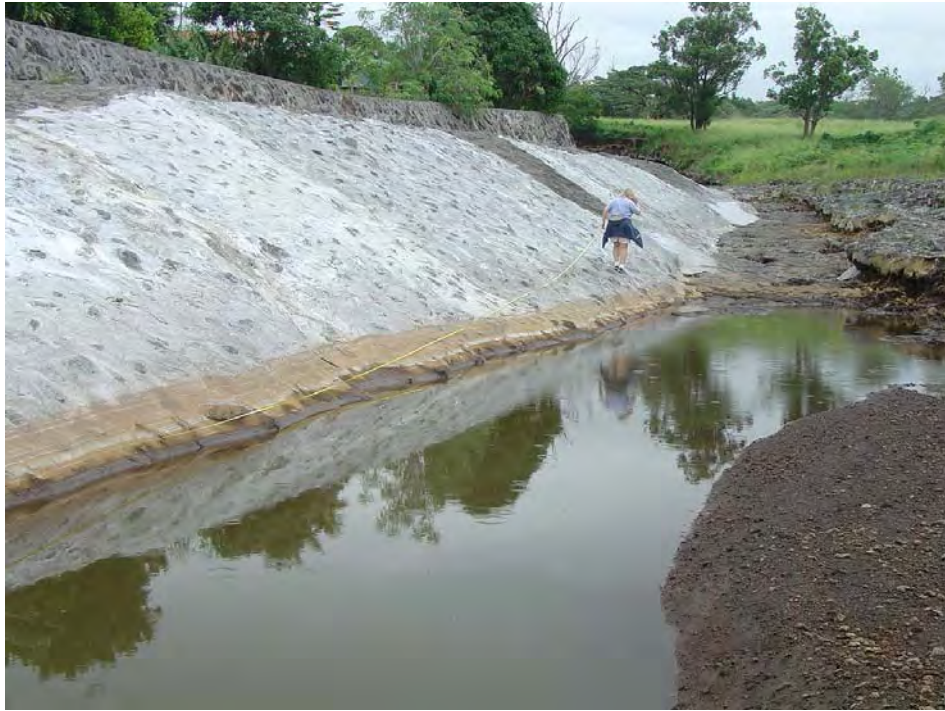
v. Sta. 12+15 (approx), 97 LF toe repair, verify when dry

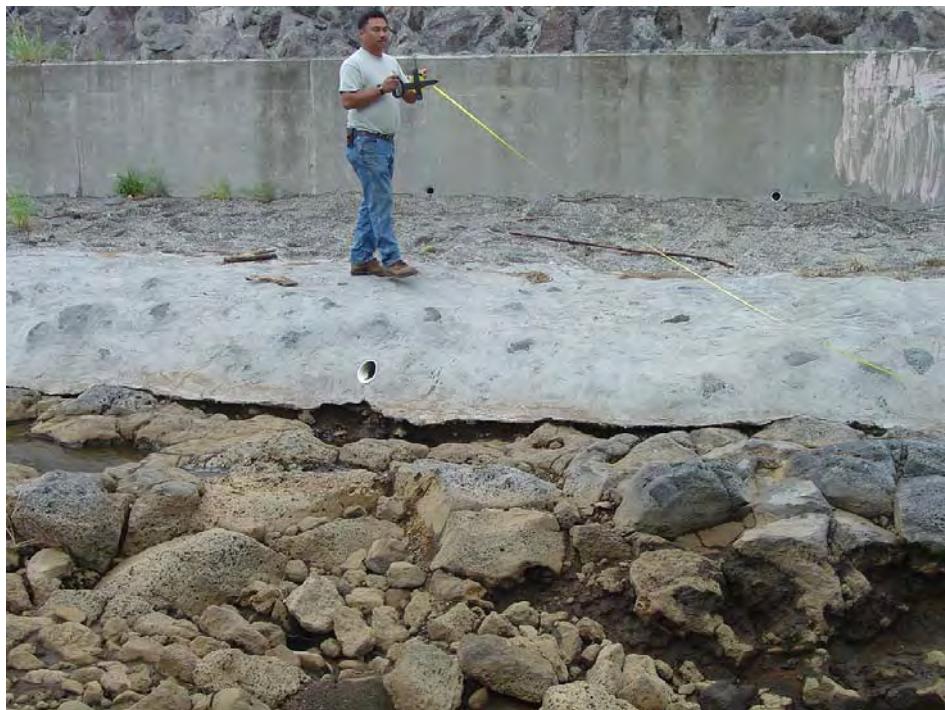
w. Sta. 10+50 (approx), 96 LF toe repair, toe needs to be keyed in

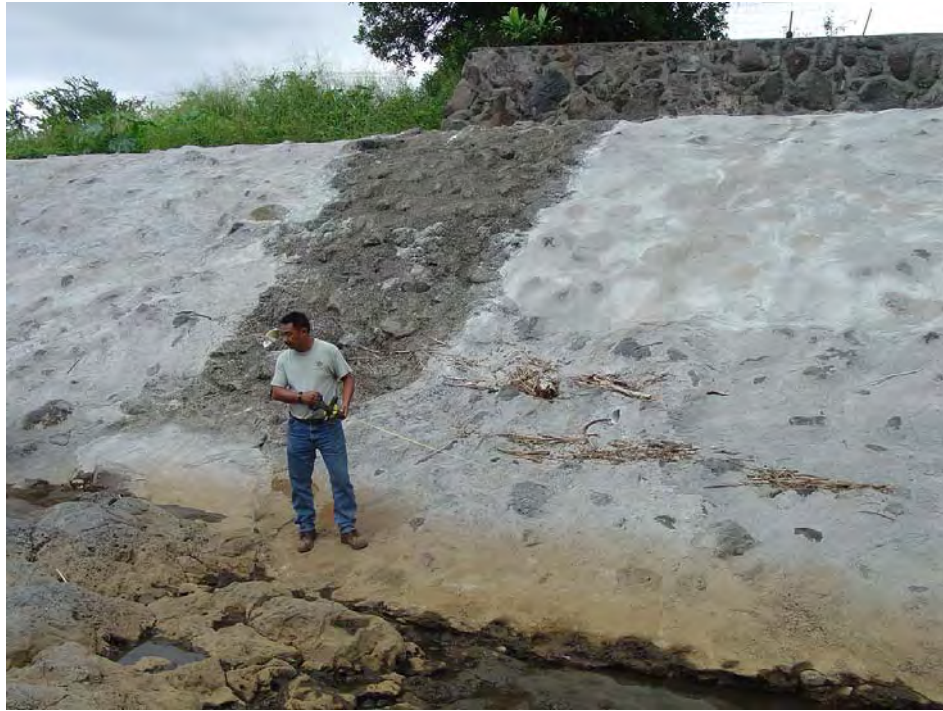
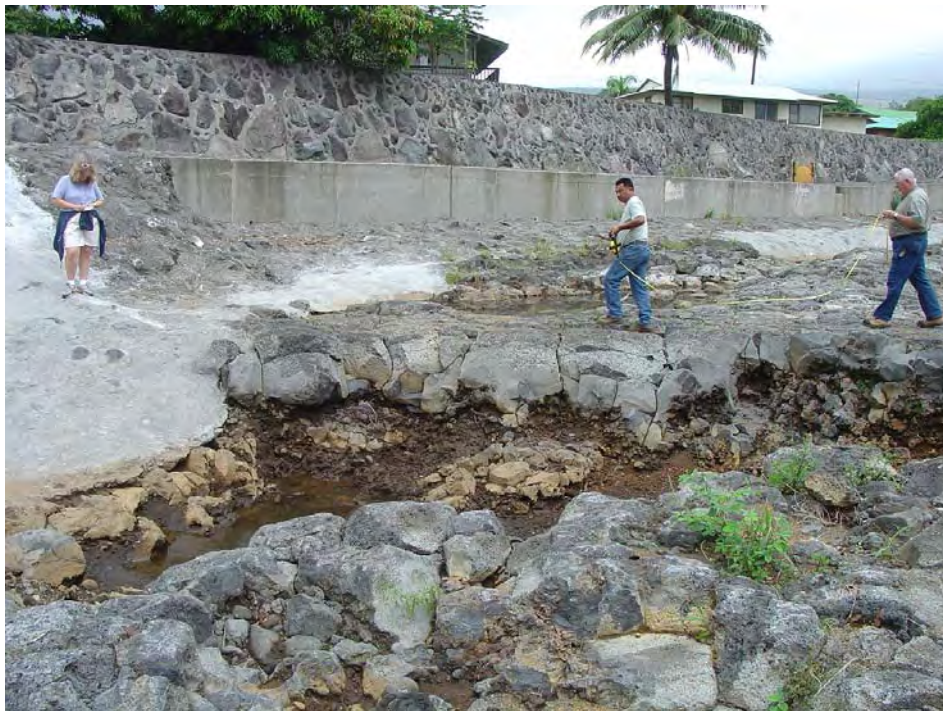
- x. Sta. 8+77 (approx), 56 LF toe repair, address the hole in channel or the toe will fail in the future, hole is 45 LF wide by 56 LF direction of flow by 20 inches deep

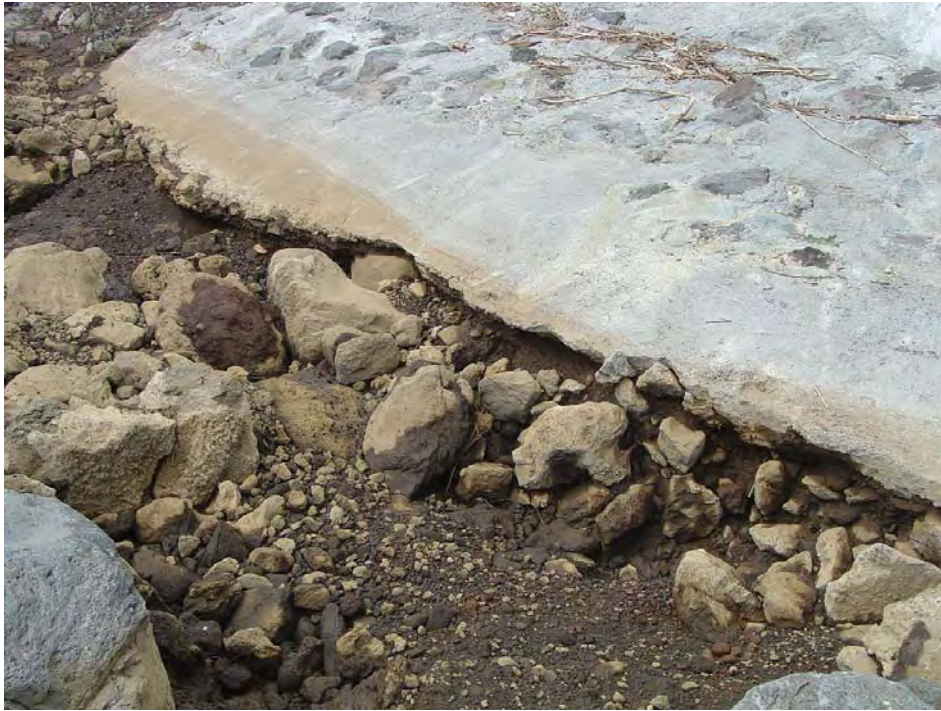
y. Sta. 7+00, 35 LF toe repair, patch hole 5 feet out from toe, downstream end of project
